# Automotive Diagnostic Report

DW10CD Engine ECU Trace Analysis — Turbo Boost Lag & Air Doser Mechanical Fault

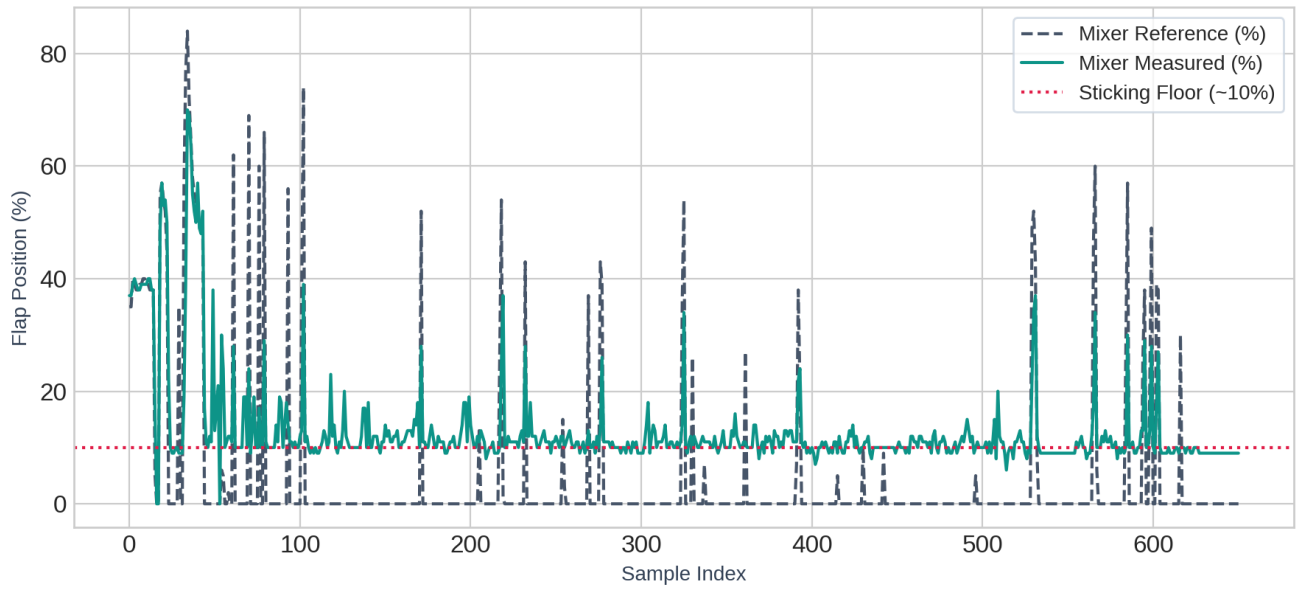
Air Doser (Mixer Flap) Mechanical Sticking

The ECU issues a 0% command when maximum fresh airflow is required. Out of 485 instances requesting 0%, the flap failed to reach 0% single time, settling at a persistent mechanical floor around 10%.

| Parameter / Metric | Expected Nominal | Measured Log Value | Evaluation |
|---|---|---|---|
| Wide Open Flap Position | 0.0% | 9.0% – 18.0% (Mean ~11.0%) | <b>FAIL (Sticking)</b> |
| Mean Position Error | < 2.0% | 11.07% | <b>POOR TRACKING</b> |
| Maximum Transient Delta | 0.0% | 45.0% (Requested 69%, Actual 24%) | <b>SEVERE BINDING</b> |

- Air Doser Assembly Cleaning:** Remove the air doser housing (*boîtier papillon*) and inspect the internal throttle plate for heavy carbon and oil sludge accumulation. Clean thoroughly using carb/intake cleaner.
- Mechanical & Gear Inspection:** Check the internal return spring and plastic gears for binding, mechanical damage, or gear tooth stripping causing the ~10% zero-point offset.
- Diagnostic Calibration:** After cleaning or replacement, perform an Air Doser Adaption / Relearn procedure using Diagbox to recalibrate zero-position limits.

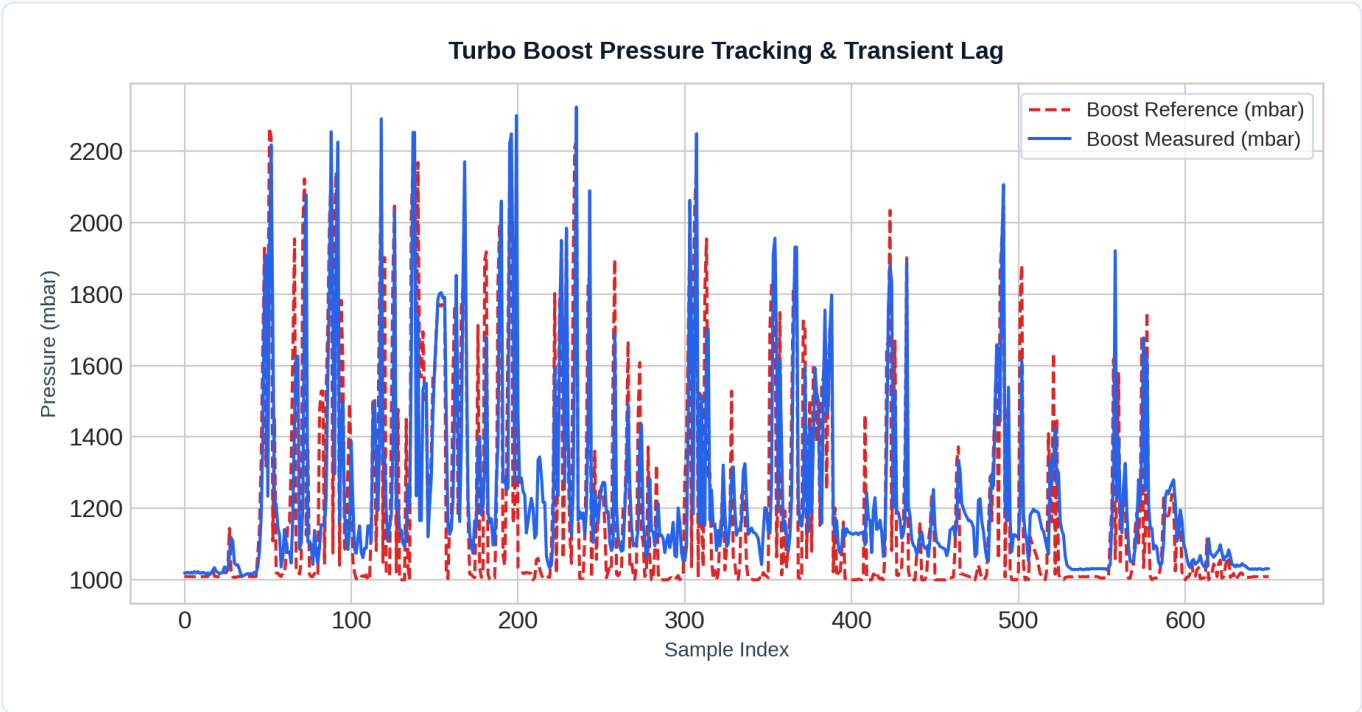
## 2. Severe Transient Underboost Spikes

During tip-in acceleration from low RPM, target boost increases rapidly, but airflow restriction prevents timely spooling. The turbocharger VGT actuator responds correctly (closing to 90–98%), ruling out a faulty boost solenoid or actuator failure.
